Pickle Line Drives Upgrade in Integrated Stages to Minimize Downtime

Keywords: Pickle Line, Drives, Upgrade, Modernization

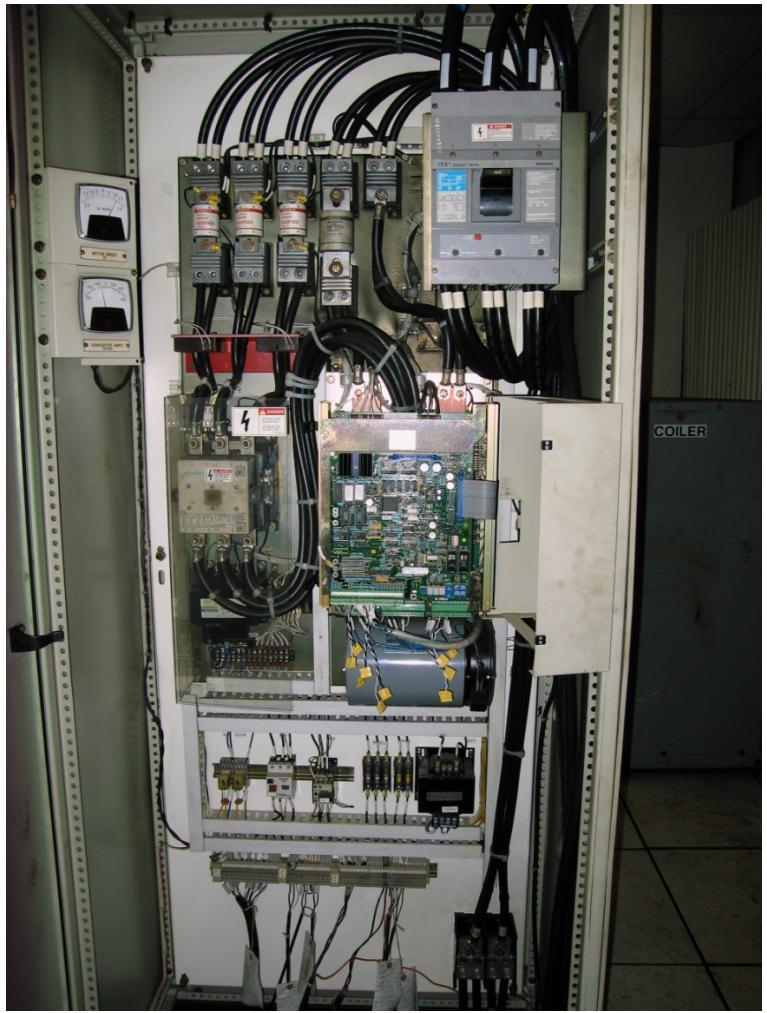
Figure 1. Existing Uncoiler Drive

The existing DC Drives were good drives for their time, but they were obsolete and replacement parts were getting increasingly difficult to obtain. The primary reason for the Drives Upgrade was their obsolescence.

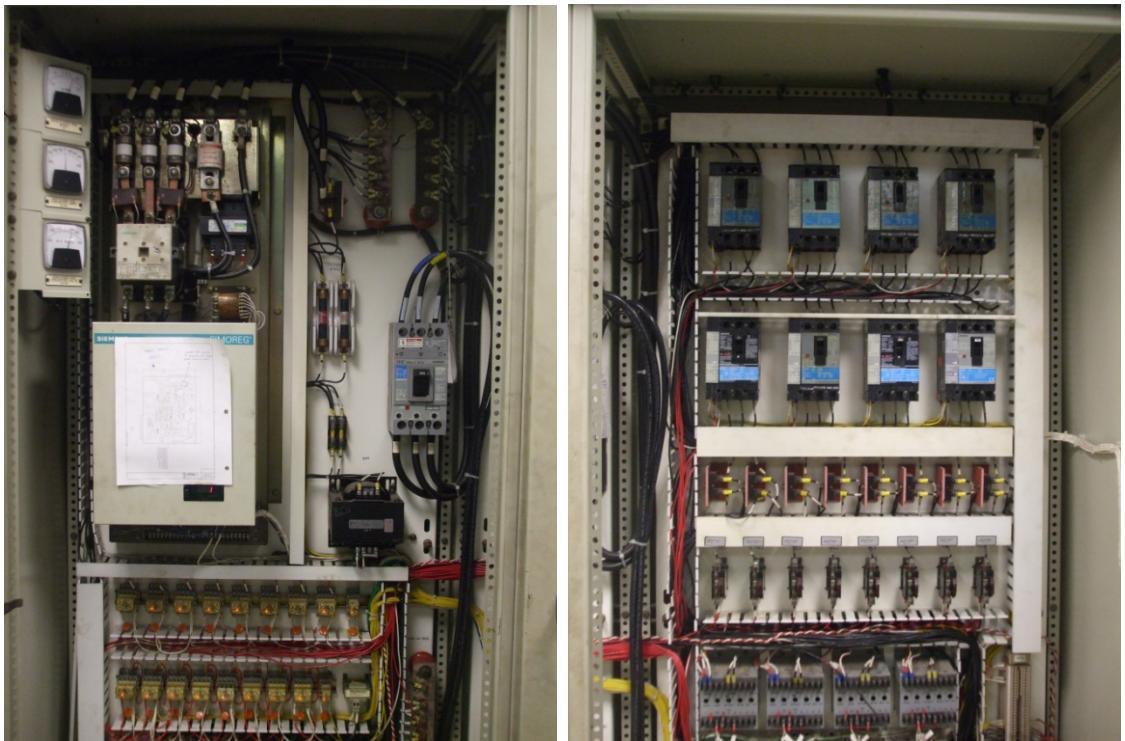
Figure 2. Existing 8-Motor Squeegee DC Drive Cabinet

15 of the 16 existing Squeegee Motors in the Wet Section were DC Motors. The acid fumes in the Wet Section detrimentally affected the Squeegee Motors' commutator conditions.

The existing 10hp Squeegee DC Motors were also frequently overloaded.

8 of the 15 Squeegee DC Motors had their armatures in parallel on one DC Drive. The remaining 7 Squeegee DC Motors had their armatures in parallel on another DC Drive. All 15 of them had separate Field Controllers, but no speed feedback devices.

The decision was made to replace the 15 Squeegee 10hp DC Motors with 20hp AC Motors for decreased maintenance costs, increased motor life, decreased relative motor loads, and better motor control. The 16th Squeegee Motor was already an AC Motor, but was replaced with one of the new 20hp AC Motors.
